**TAUNTON RIVER BASIN  
EASTON, MASSACHUSETTS**

**LONGWATER POND DAM  
MA 00171**

# **PHASE I INSPECTION REPORT NATIONAL DAM INSPECTION PROGRAM**

**APRIL 1979**

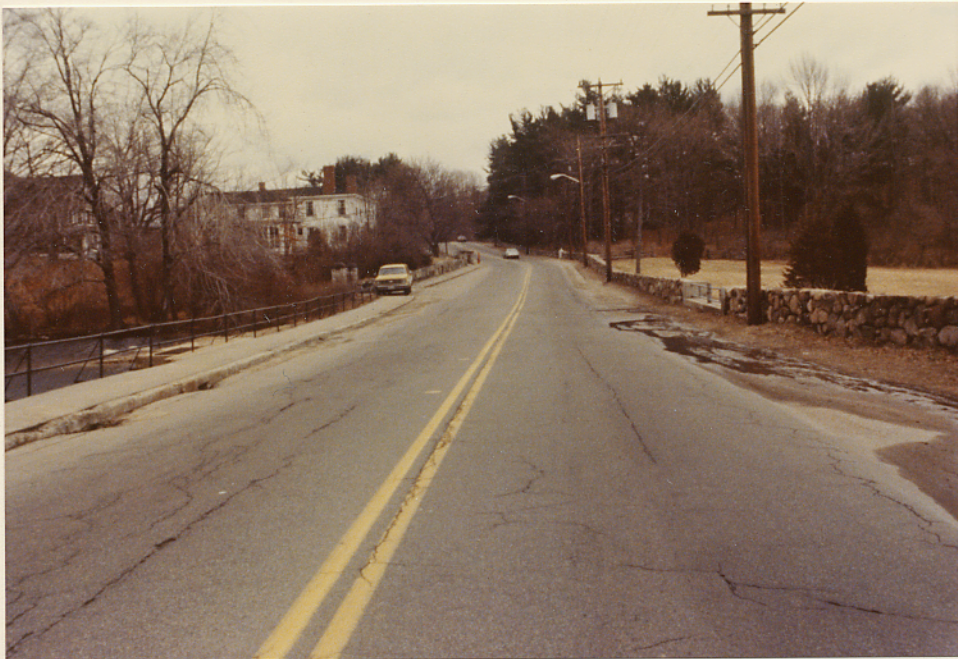
The downstream face of the dam is in good condition. Surface cracks and local depressions are visible on the paved crest of the dam. This should be repaired to prevent further deterioration of the crest and upper slopes.
- c. Appurtenant Structures. The outlet works for the pond consist of a central outlet with stoplogs, and a side channel spillway. The inlet

**NO. 1 WEST-EAST VIEW OF DAM CREST (MAIN STREET)**

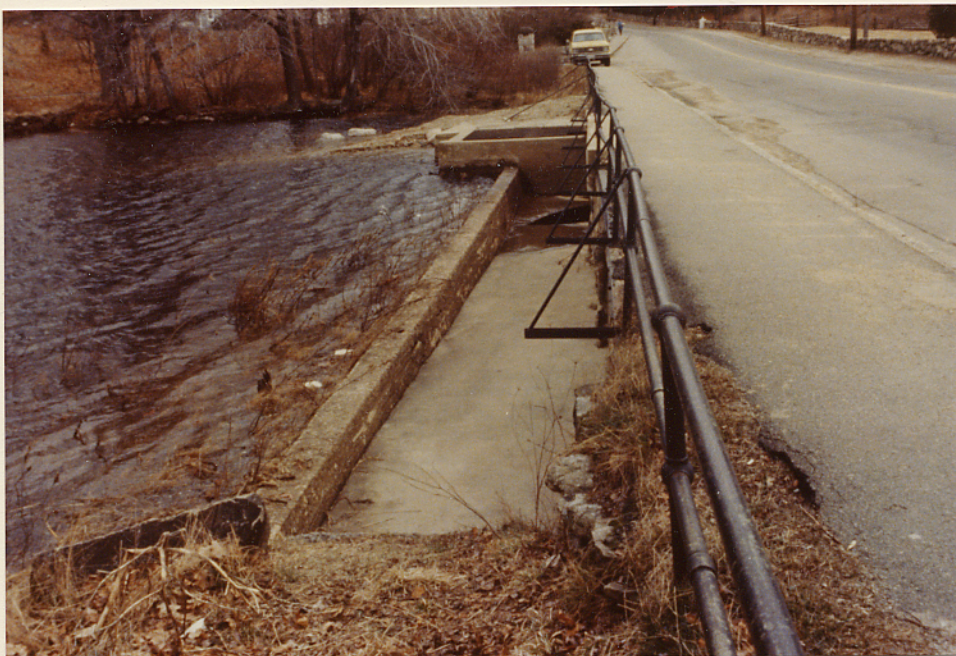
The side channel spillway is constructed of concrete along the upstream slope of the right embankment. Water is seeping through the concrete crest of the spillway, near the discharge end of the trough. The seepage area is a horizontal zone of spalled and eroded concrete, approximately 6 inches wide and 12 feet long. The concrete on the floor of the channel is also slightly spalled.

**NO. 2 UPSTREAM VIEW – SIDE CHANNEL SPILLWAY-OUTLET WORKS**

- (1) Place riprap on the upstream slope of the embankment.
- (2) Compact the earthfill placed adjacent to the central outlet.
- (3) Repair the leak through the crest of the side channel spillway, adjacent to the outlet.
- (4) Repair the scoured and eroded concrete in the side and center walls of the central outlet. Repair the spalled concrete.
- (5) Repair the paved surface of the crest of the dam.
- (6) Implement a systematic program of maintenance inspections. As a minimum, the inspection program should consist of a bi-annual inspection of the dam and appurtenances, supplemented by additional inspections during and after severe storms. All repairs and maintenance should be undertaken in accordance with all applicable State regulations.

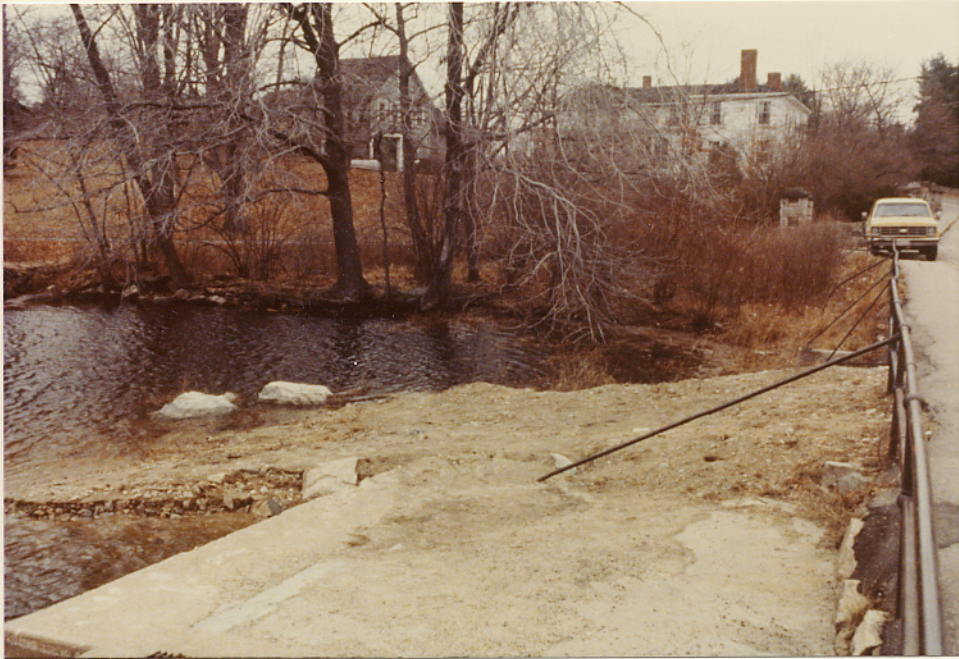
- b. Dam. Longwater Pond Dam is an earthfill dam with an asphalt paved roadway (Main Street) on the crest. The dam is generally in fair condition. No seepage through the embankment was observed, however, there were other signs of distress at the site. There is no riprap on the upstream slope of the embankment at the base of the concrete wall, and some erosion is visible at the upstream face of the right abutment. At the left abutment (to the left of the outlet works), the upstream slope has been covered with uncompacted earthfill. There are already signs of erosion in this area, and more is likely to occur unless the bank is properly compacted and protected with riprap.

**NO. 3 UPSTREAM VIEW – LEFT ABUTMENT**

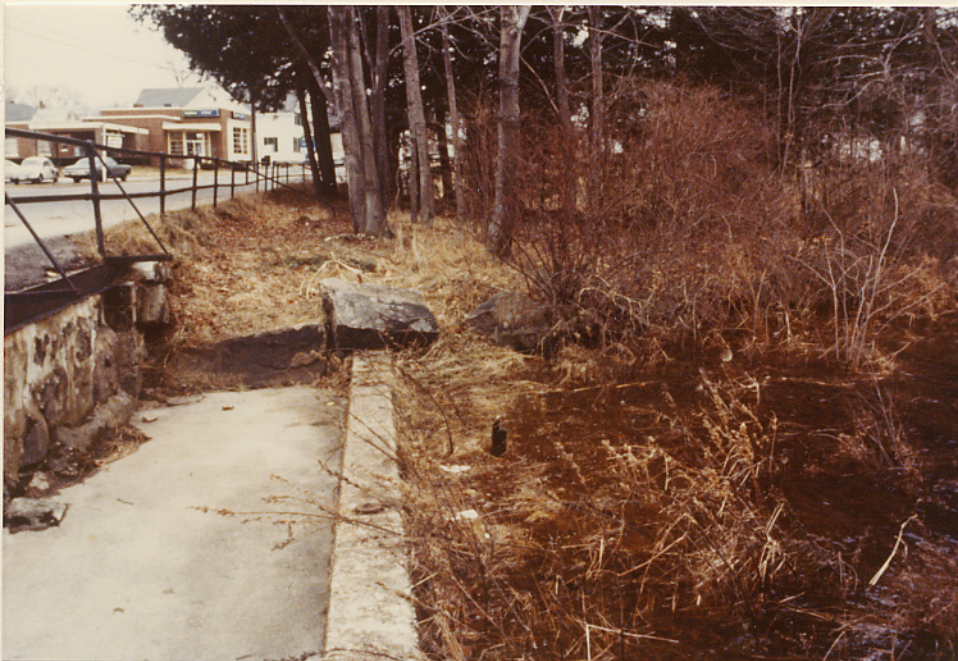
**NO. 4 UPSTREAM VIEW – RIGHT ABUTMENT**

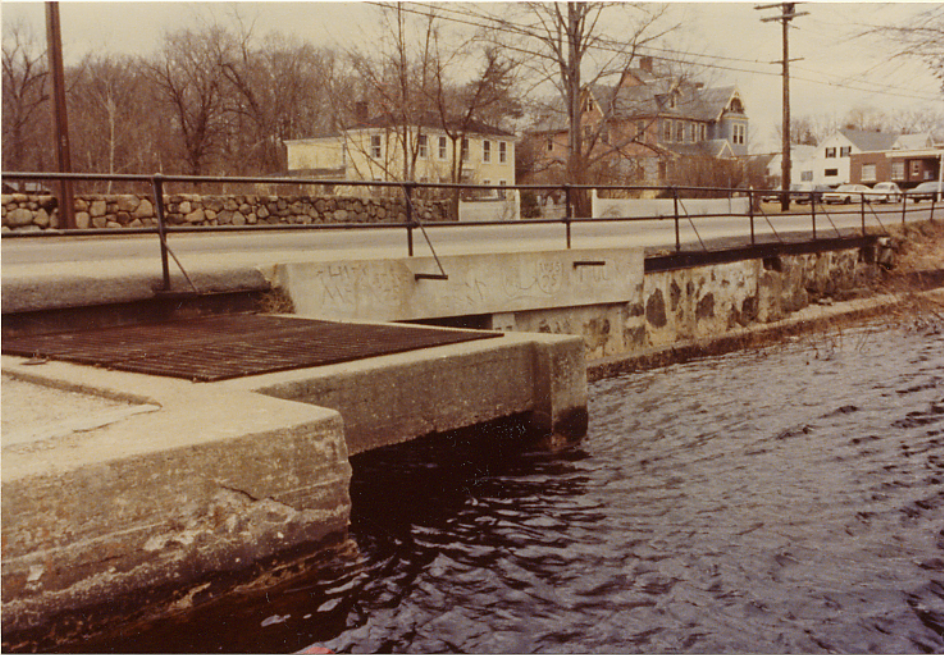
to the central outlet is 7 feet high and 7.5 feet wide. A center concrete wall divides the outlet into two bays. This wall, and the outer side walls, support the two sets of stoplogs. The concrete at the base of the side walls and center wall is eroded, and spalling of the concrete was noted elsewhere.

**NO. 5 VIEW OF OUTLET WORKS**

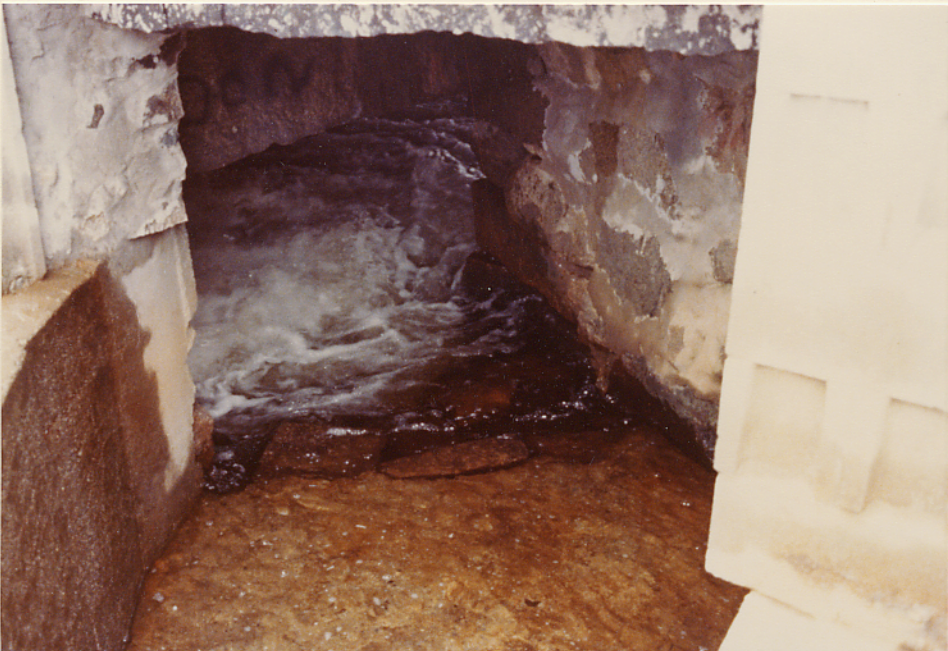
**NO. 6 VIEW OF SIDE CHANNEL SPILLWAY OUTLET**

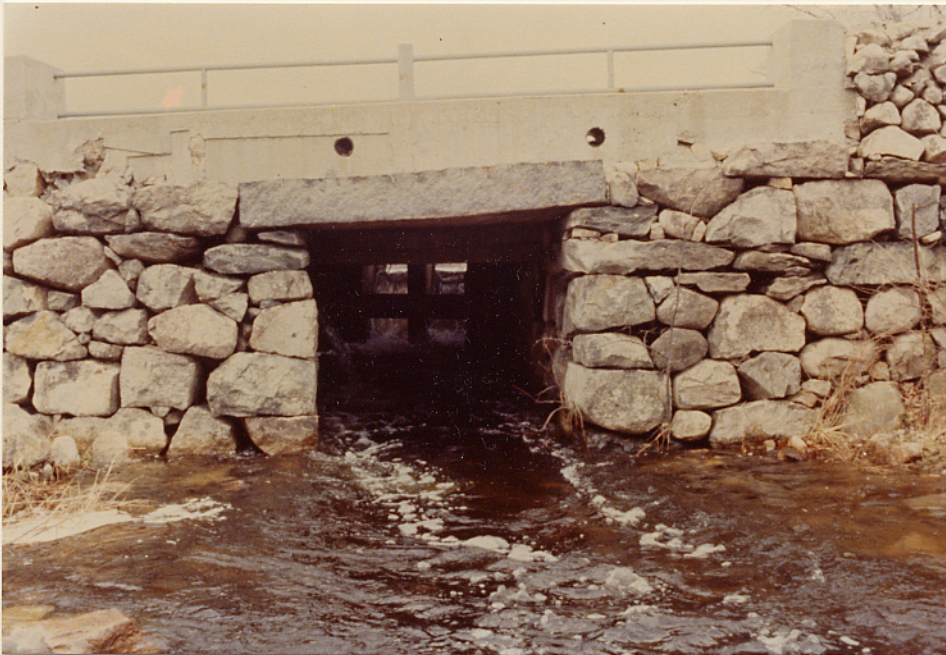
The spillway and central outlet both discharge into a 7 by 7.5 foot box culvert under Main Street. The culvert is constructed of concrete and stone masonry, and appears to be in good condition. A 12-inch cast-iron pipe crosses the culvert along the centerline of the roadway, 3 to 4 feet above the invert. This pipe could trap debris and obstruct the flow from the pond.

**NO. 7 VIEW OF OUTLET WORKS – DOWNSTREAM**

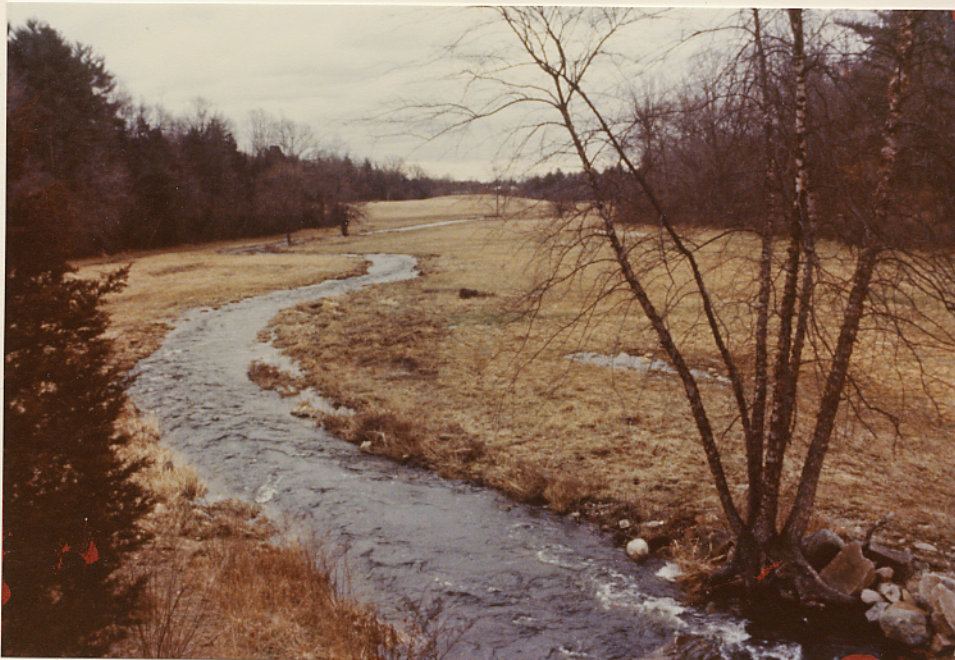
**NO. 8 VIEW OF DOWNSTREAM DISCHARGE CHANNEL**
